URGENT – Field Safety Notice

ISO 7176-19 Hook labels for the AVIVA™ RX power wheelchair

Invacare reference: FSN_AVIVA_Hook_Label_2021-11

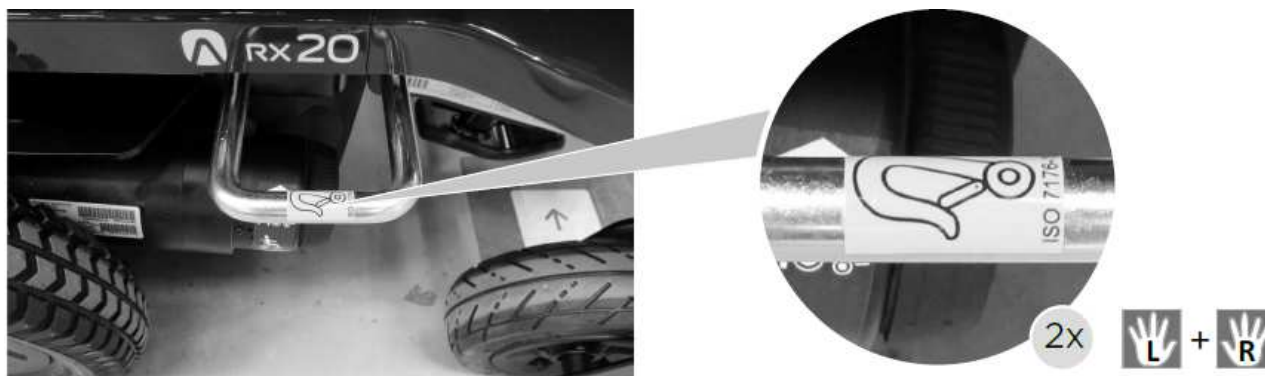
Invacare discovered that an ISO 7176-19 requested hook label is missing on the easily accessible front tie-down points (Option ***2894) which can be ordered as additional option for power wheelchairs. The labels are only missing on the additional easy accessible tie-down points for the Aviva RX. It is present on all standard tie-down points (4- or 6- point tie down system).

1. Review your existing stock to locate the affected units.
2. Review the attached work instruction sheet (60131411~A - ISO 7176-19 Hook labels for the AVIVA™ RX)
3. Check on the devices if the labels are already present. If so, continue with point 7.
4. Attach the provided ISO 7176-19 Hook labels when missing on affected units during the next regular scheduled maintenance service following the clear work instruction sheet provided.

NOTE: The provided labels shall ONLY be attached if the wheelchair has been ordered in a configuration to be used as Vehicle Seat, according to ISO 7176-19 (Options ***1494 or ***1401). This is also indicated by the same label being present, already, on other tie-down points. The provided work instruction shows how to attach the provided ISO 7176-19 hook labels on tie-down points located, respectively, on the left-hand side and right-hand side of the mobility device.
