Urgent Field Safety Notice

Action 3 Junior – Push bar finger bolts

Date: 17th November 2010

Invacare Ref: FSN 035

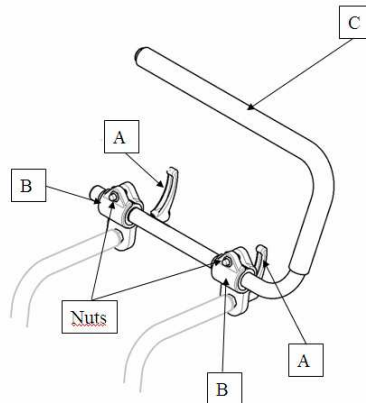
In the interests of the safety of our customers we would like to bring your attention to a potential failure of Action 3 Junior push bar M6x30 finger bolts (rep A).

The failure of finger bolts can lead to injuries if control of the chair is lost.

A modification has been implemented starting from the SN051021027909 (28th June 2010). The effectiveness of this solution has been confirmed by specific fatigue tests which are in accordance with ISO 7176 requirements.

Please be advised that if you have purchased an Action 3 Junior manual wheelchair with push bar manufactured from the SN050714224781 to the SN051021027909, you will be contacted by Invacare and provided with a free of charge kit which will be available in December.

Please contact Invacare if you purchased this item as a spare part before 06th October 2010, and request a free of charge upgrade kit for your wheelchair. Please quote kit number 1545634, and advise the serial number of your wheelchair.

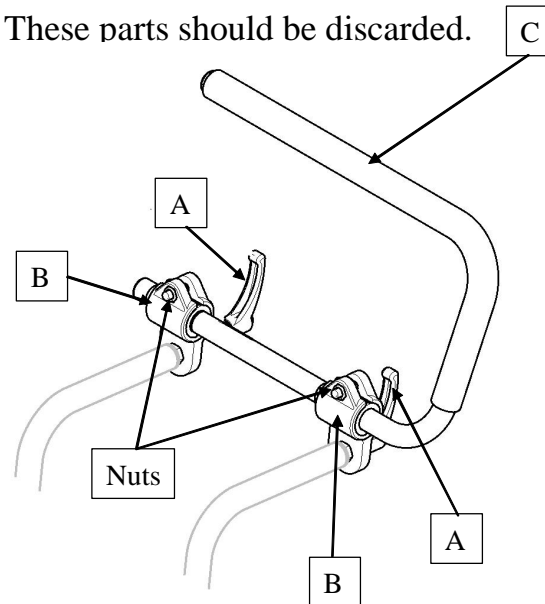
Remove the parts on the chair

- Unscrew the both nuts of the plastic part and remove the original push bar (piece C) from the chair.
- Remove the Handles M6 (pieces A) – These parts should be discarded.
- Remove the Plastic parts (pieces B) – These parts should be discarded.

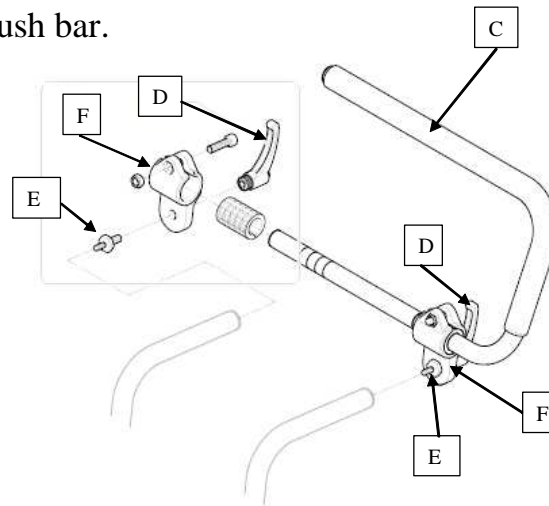
Assemble the new parts provided with the kit, on the chair.

- Fit the M6/M8 Adaptor using 17mm spanner (pieces E) – torque 10Nm.
- Assemble the Plastic parts (Pieces F).
- Screw the Handles (pieces D).
- Replace the original Push bar (piece C).
- Tighten Handles (D) to secure Push bar.
